ARCHEOLOGICAL INVESTIGATIONS AT THE LINCOLN HOME NATIONAL HISTORIC SITE, SPRINGFIELD, ILLINOIS

By
Floyd Mansberger

NORTHERN ILLINOIS UNIVERSITY
DEKALB, ILLINOIS

Prepared For The National Park Service
Midwest Archeological Center-Lincoln, Nebraska

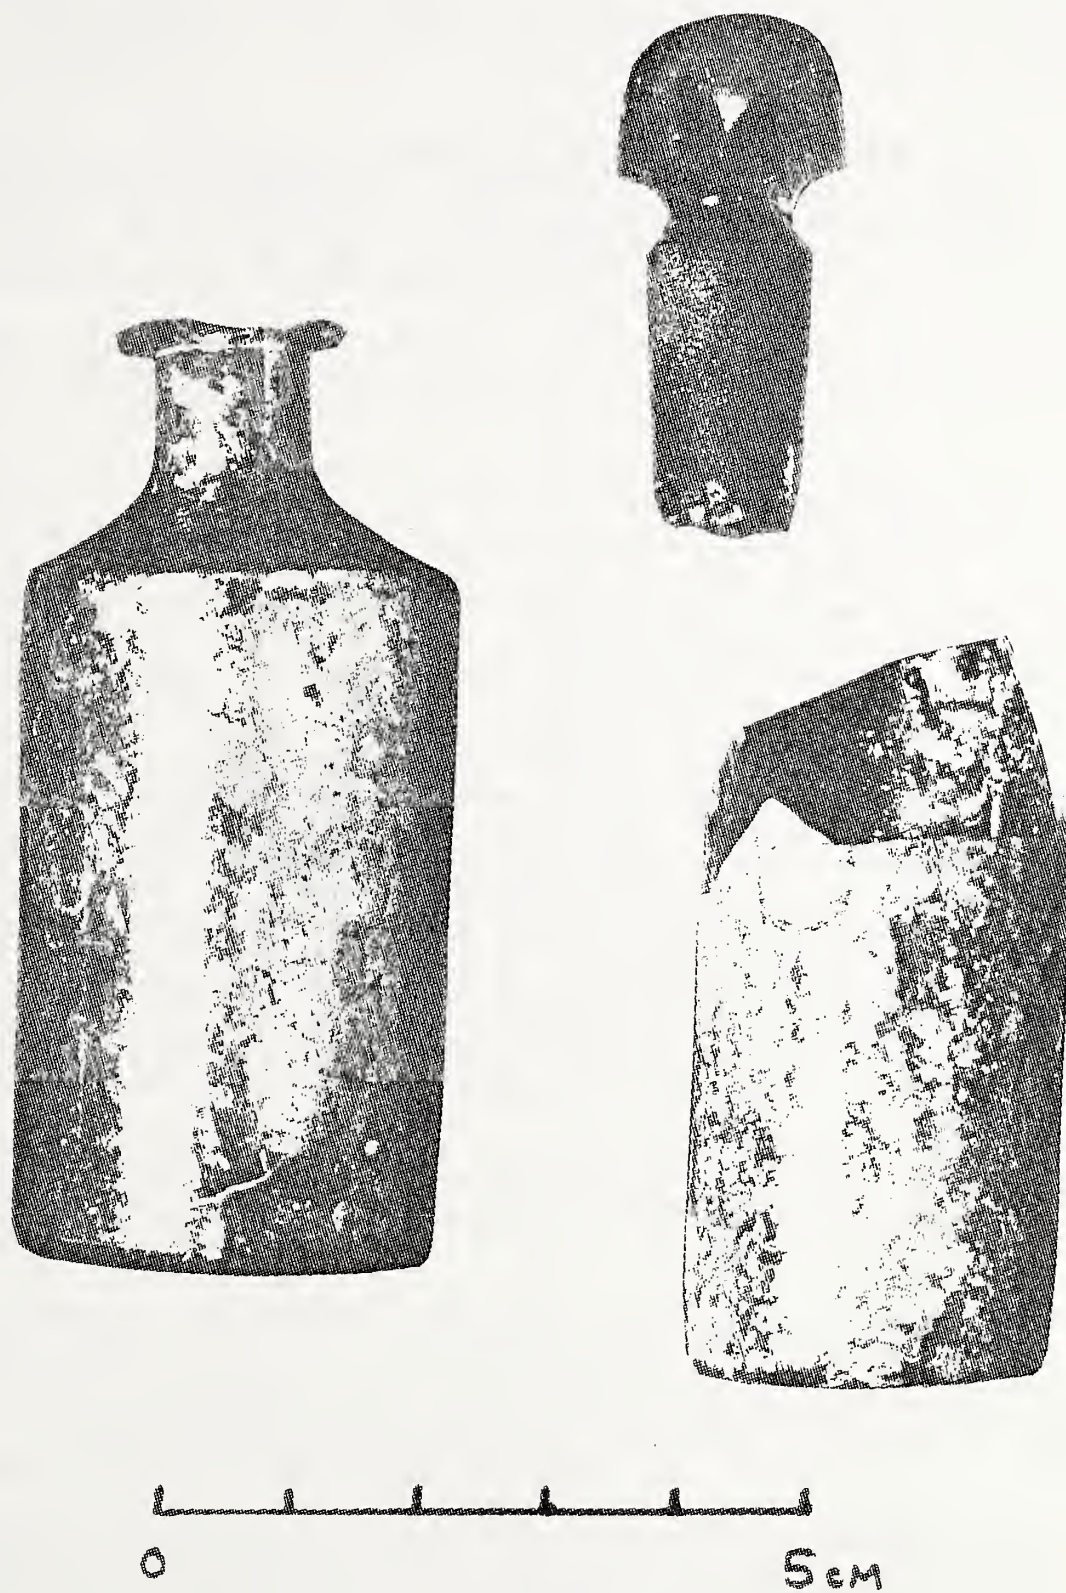
FIGURE 69. Lincoln Site, Glass Artifacts Recovered From the Well Located Beneath the East Porch.

Although small in number, a wide assortment of artifacts was recovered from the Lincoln well. The ceramics recovered were extremely small in number (n=4). The only decorated sherds recovered were relief decorated wares (n=2). A bit more variability was evident in the glass artifacts recovered from the well. The glass included architectural items such as aqua window fragments (n=2), as well as kitchen items such as molded tumbler/tableware fragments (n=2). Other kitchen/household glass items found in the well consist of a whole fragile lipped vial with a pontiled base, as well as fragments of a second embossed vial (Figure 69). The base of the second vial also was pontiled and had enough embossed lettering present to ascertain that it was from a bottle marked, "DR D. [JA]YNES / CARMINATIVE / BALSAM / PHILADA." The presence of the bottle of carminative lends credibility to the fact that these deposits were associated with the Lincoln family. In the account book of leading Springfield druggists Corneau and Diller is listed the purchase of one "Bottle Carminative" by the Lincolns for \$0.25 on 8 October 1857 (Pratt 1943:151). It is not to say this is the same bottle as found in the well, only that the Lincoln family definitely were using bottled carminative. The Illinois Daily Journal (2 January 1855) contains an ad run by Corneau and Diller that states:

This bottle, discussed in McKearin and Wilson (1978:282), is dated by them as "1840's." McKearin and Wilson (1978:296) also state that Dr. David Jayne was listed in the Philadelphia city directories as a doctor in 1839. In 1845 Dr. Jayne began a yearly medical publication that boosted sales of his products. The firm was in business until 1887. Wilson and Wilson (1971:47,122) state that Dr. Jayne first started bottling in 1838. As McKearin and Wilson (1978:297) state, "Dr. Jayne's carminative balsam was but one of many combining aromatic

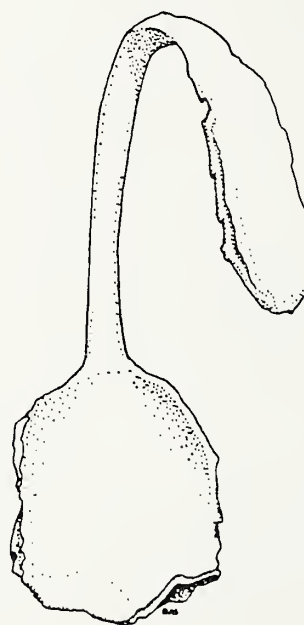
FIGURE 71. Miscellaneous Items Recovered From Well Beneath The
East Porch of The Lincoln Site
A. Unknown Item
B. Pewter Spoon

Metal items from this feature consisted of a large number of machine-cut nails (n=42), as well as several fragments of "tin" containers. Other metal items recovered included two straight pins, a pewter knob possibly to a tea- or coffee pot (Figure 70), as well as a badly abused pewter spoon and an unidentified piece of metal (Figure 71). It is possible the pewter spoon could have been a child's toy used for digging in the ground around the house -- typical of child's play today. A single two-hole shell button and three small (5/16" x 1/16") cut hard rubber straps were also recovered. It is possible that these items were clothing "stays" sewn into fabric for support. The Lincoln household purchases from John William and Company included numerous fabric and sewing items. Two purchases -- one dated 5 December 1854 and the other 12 May 1859 -- list the sale of "Whalebones" to the Lincolns (Pratt 1943:146,156). Perchance these items found in the well represent common sewing items (synthetic "whalebones") used as clothing stays. A quick inspection of mid-19th century clothing in the Galena/Jo Daviess County Historical Museum substantiated the use of these black hard rubber items sewn into clothing for support.

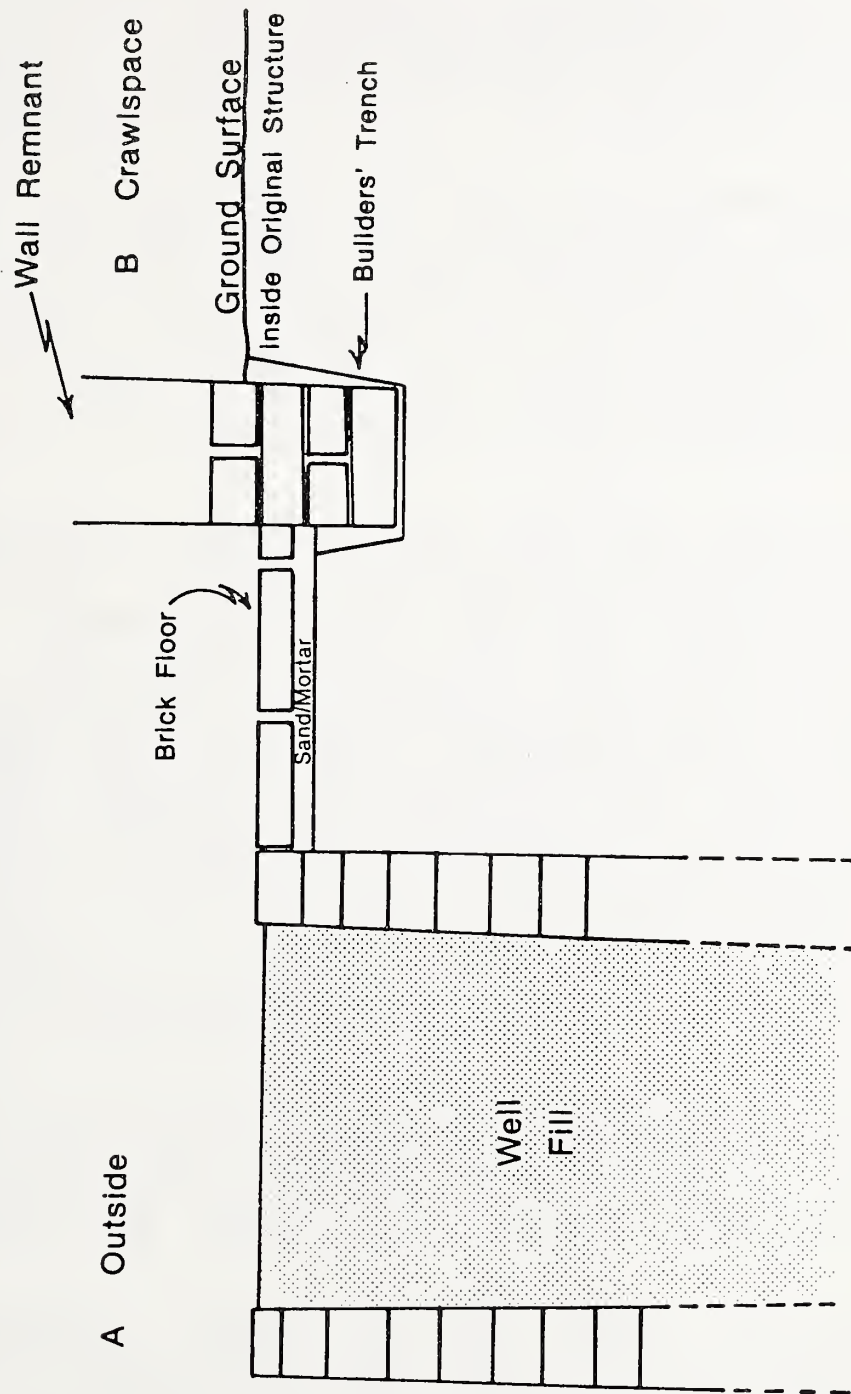
FIGURE 72. Lincoln Site, Idealized Relationship Between Original Brick Foundation Wall of East Wing (Kitchen) and the early Well Located Beneath the East Porch (See Figure 67 for Location).

Although the area between the brick wall remnant and the well was badly disturbed, three brick fragments as well as a concentration of mortar may represent the remains of a brick surface (or floor) around the well mouth. Figure 72 is an idealized representation of the relationship between the well and brick wall.

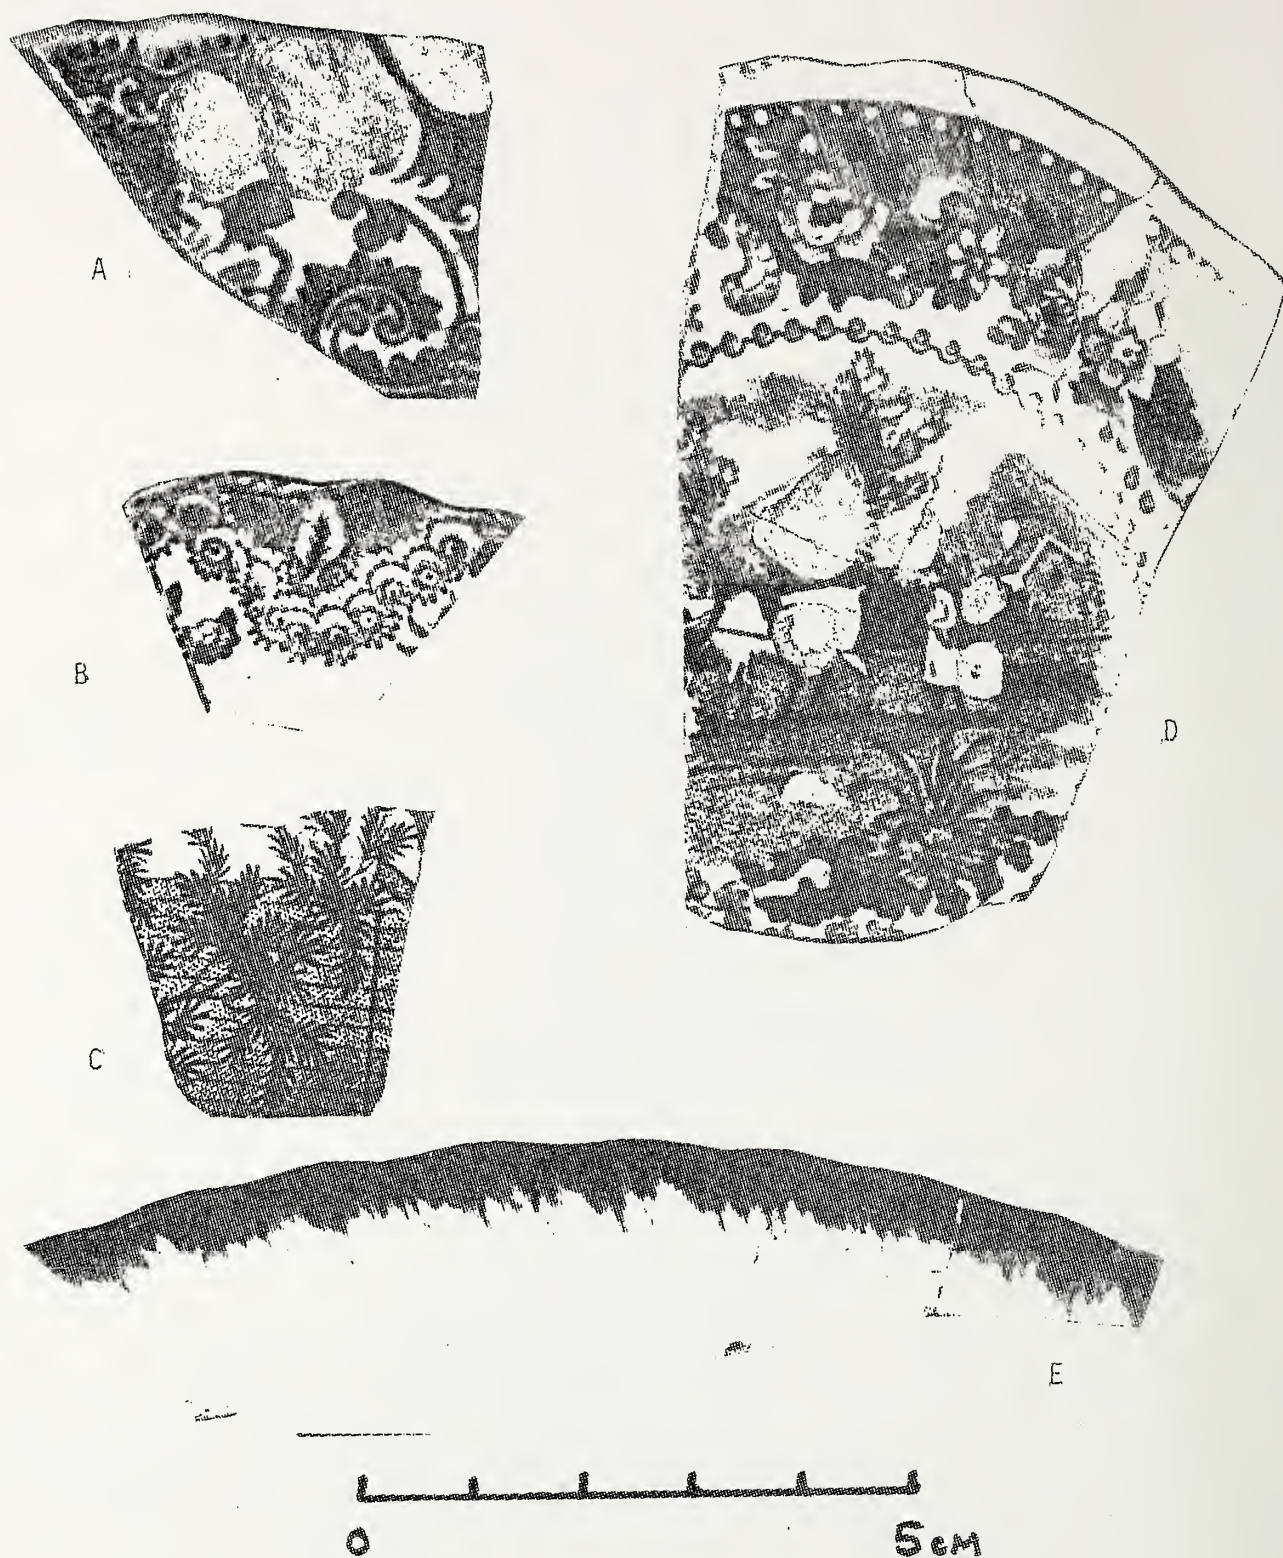
FIGURE 75. The Lincoln Site, Selected Ceramic Artifacts From
The 1985 Field Excavations
A,B,C. Transferprint Whitewares
D. Transferprint Pearlware
E. Blue Shelledge Whiteware

These included a large fragment of a shelledge whiteware plate/platter and a blue transfer printed pearlware saucer (Figure 75). The saucer was stamped with the name "Wood" on the reverse. Enoch Wood and Sons were Staffordshire potters from Burslem who produced earthenwares -- especially for the American market. They often stamped their wares with such a mark between 1818 and 1846 (Godden 1964: 685-686). This date, although slightly earlier than expected, could account for the use life of such an artifact and thus be deposited during circa 1849 to 1853.

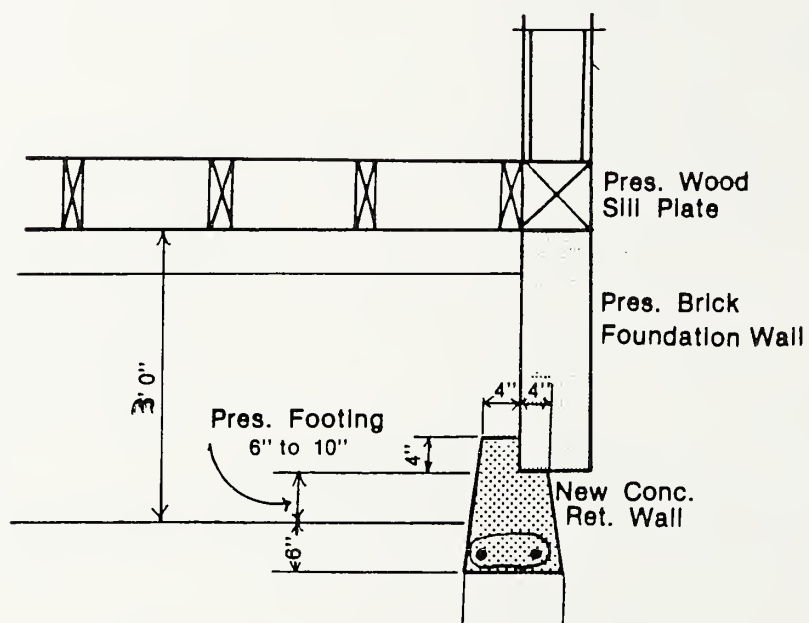
FIGURE 76. Lincoln Home, Specifications for Concrete Retaining Wall Located Beneath 19th Century Brick Wall (Courtesy of the National Park Service).

The base of the foundation walls represented by piers #7, #8, and #6, as well as behind wall #2, was reinforced by a poured concrete retaining wall. The specifications for this work were located in the 1954 plans for remodeling (Figure 76). At the same time, the area between the original kitchen south wall (wall #3) and the outer house wall represented by piers #7, #8, #6, and wall #2, was excavated so as to have a full 3'0" clearance between the ground surface and the floor joists. This effectively eliminated any of the subsurface resources that would have been associated with the area beneath the original Dresser porch.

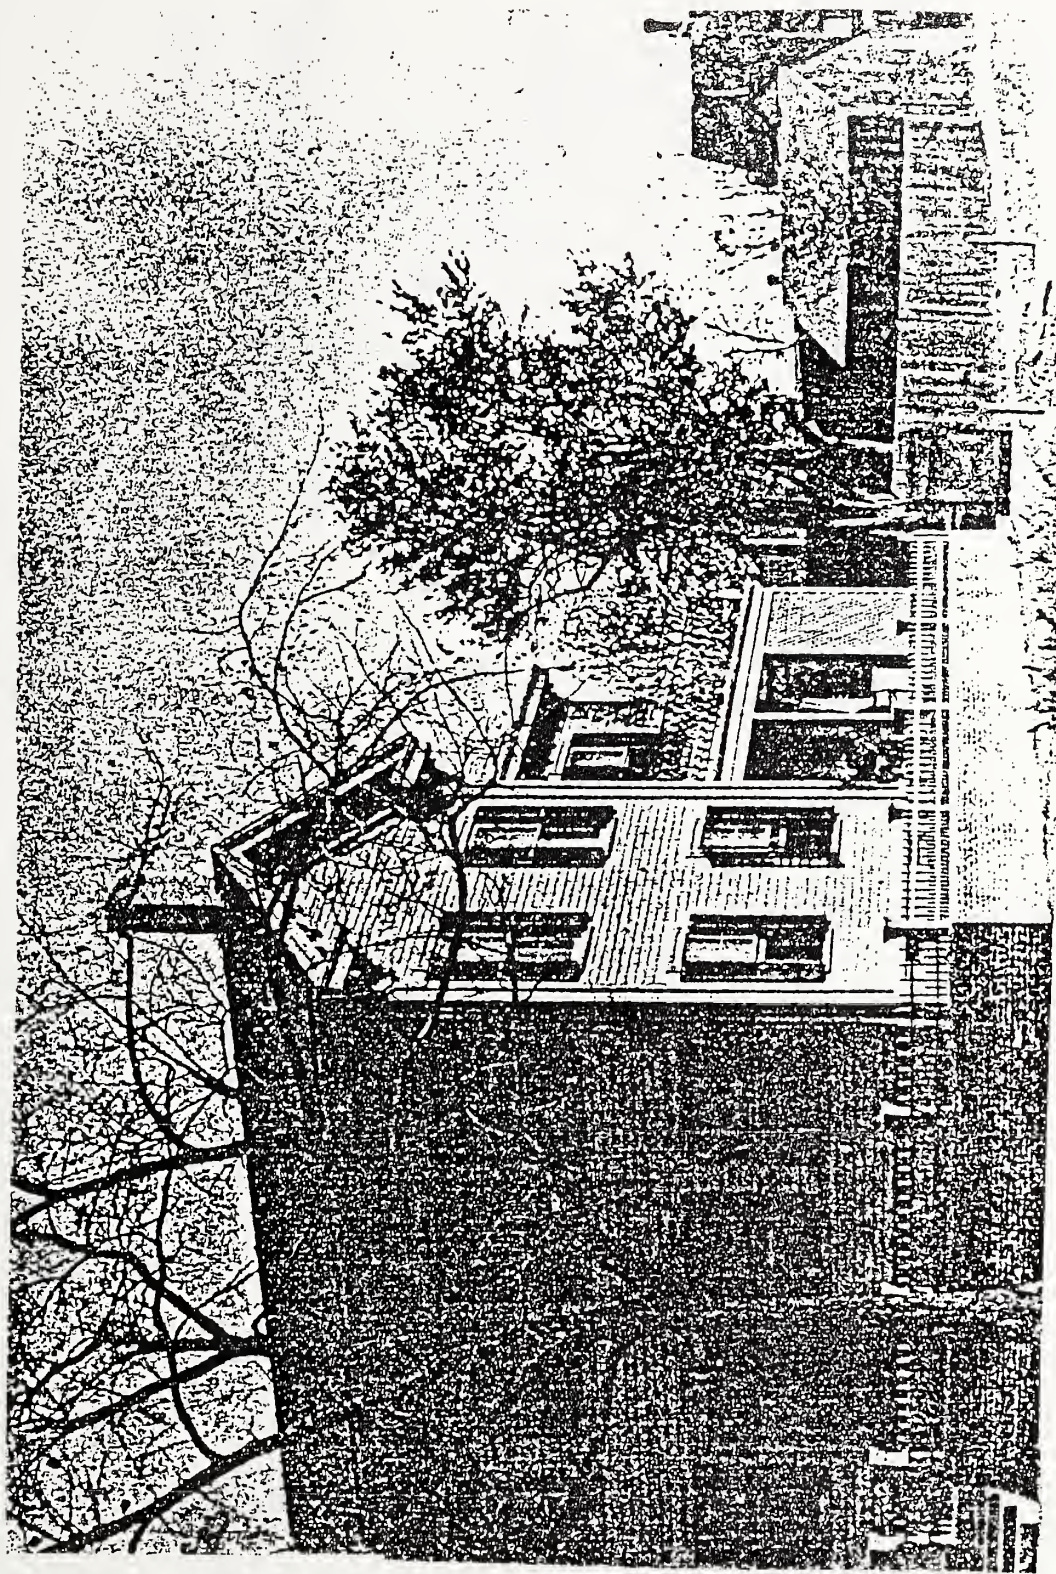
FIGURE 78. The Lincoln Barn, Circa 1888 (Courtesy of the National Park Service).

Figure 78 is a ca. 1888 photograph of the Lincoln Home showing the Lincoln carriage house or barn. The barn is designated as Feature 6 on the base maps (Figure 77). A large shallow pit (Feature 11) probably associated with the planting of bushes, has disturbed a large area of the barn. The west edge was also difficult to define. Hagen noted that an 1857 one-cent piece was found one foot below the present ground surface in the area of the carriage house. A large brass key was also found. Figure 79 illustrates two N-S sections through the barn and clearly illustrates a heavy yellow clay floor. In the southwest corner of this area, several bricks appear to have been pressed into the soil, apparently to create a brick floor, walk, or possibly a pad to support something such as a stove.

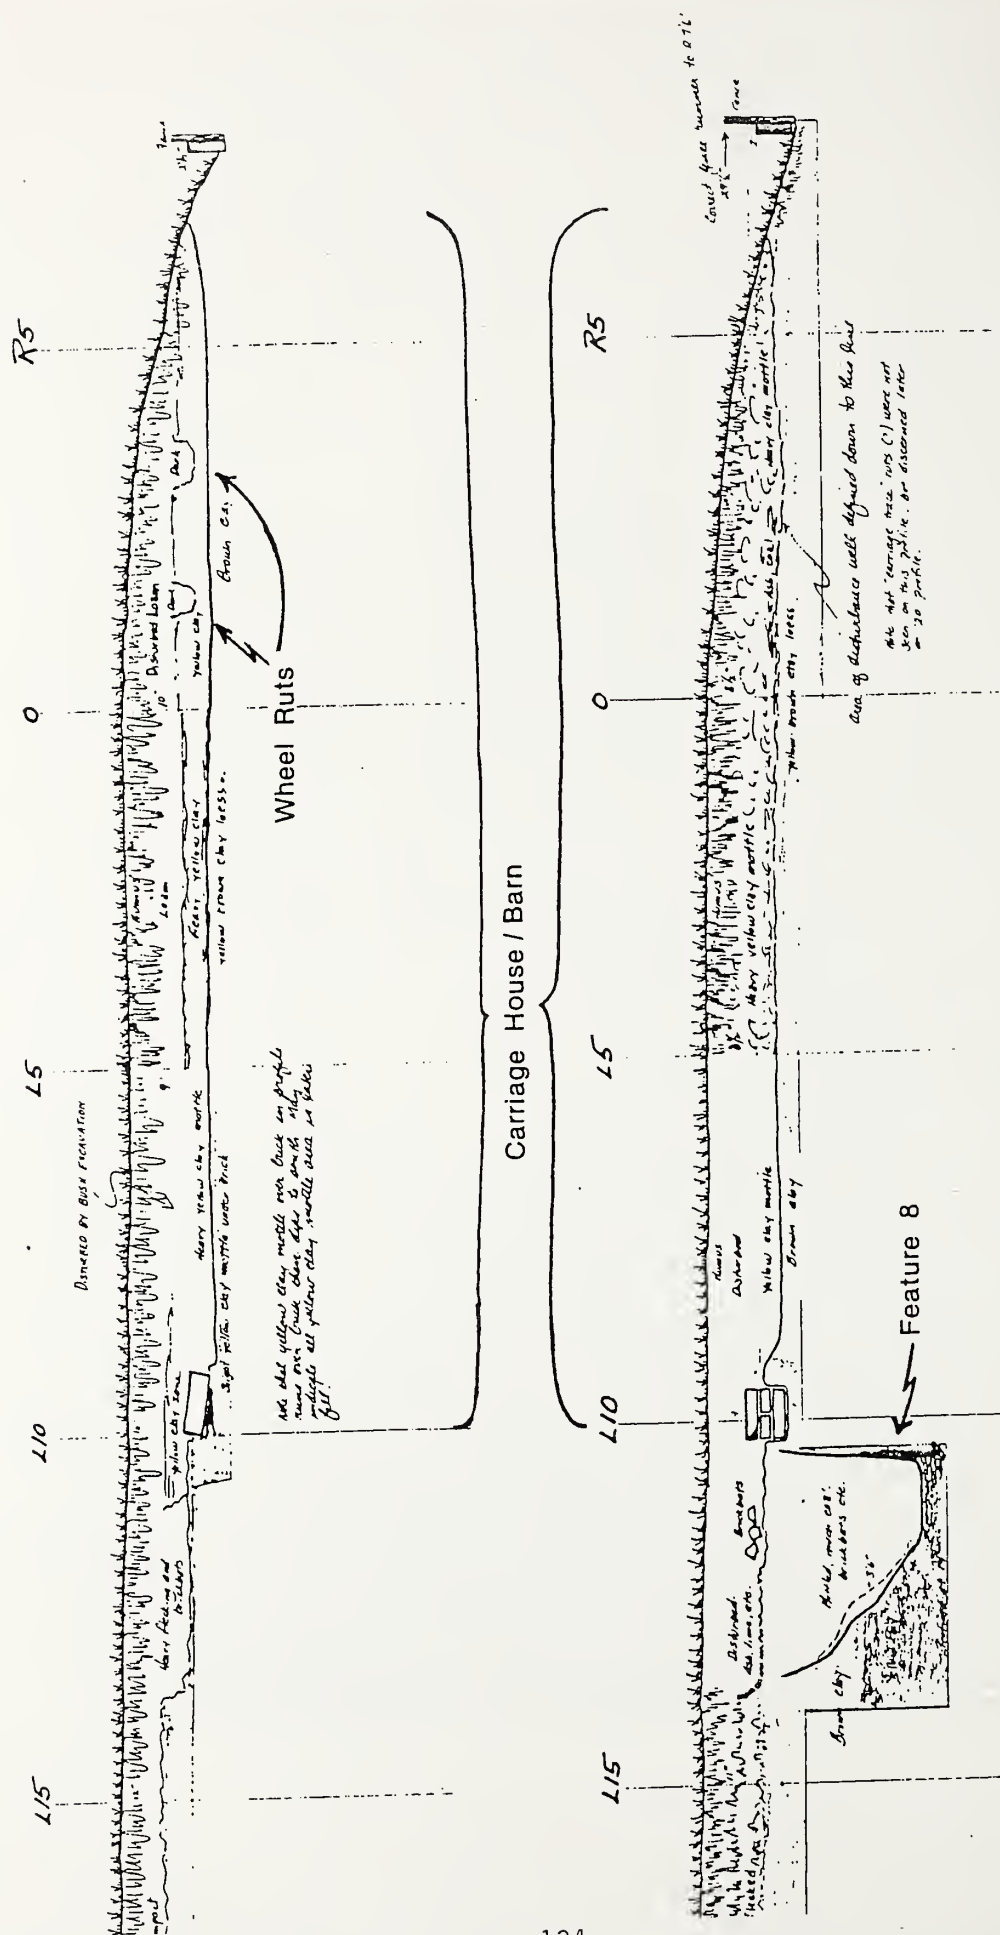
FIGURE 79. Lincoln Site, Sectional View Through Original Lincoln Barn (From Hagen's 1951 Excavation Notes on file at the Lincoln Home National Historic Site, Springfield).

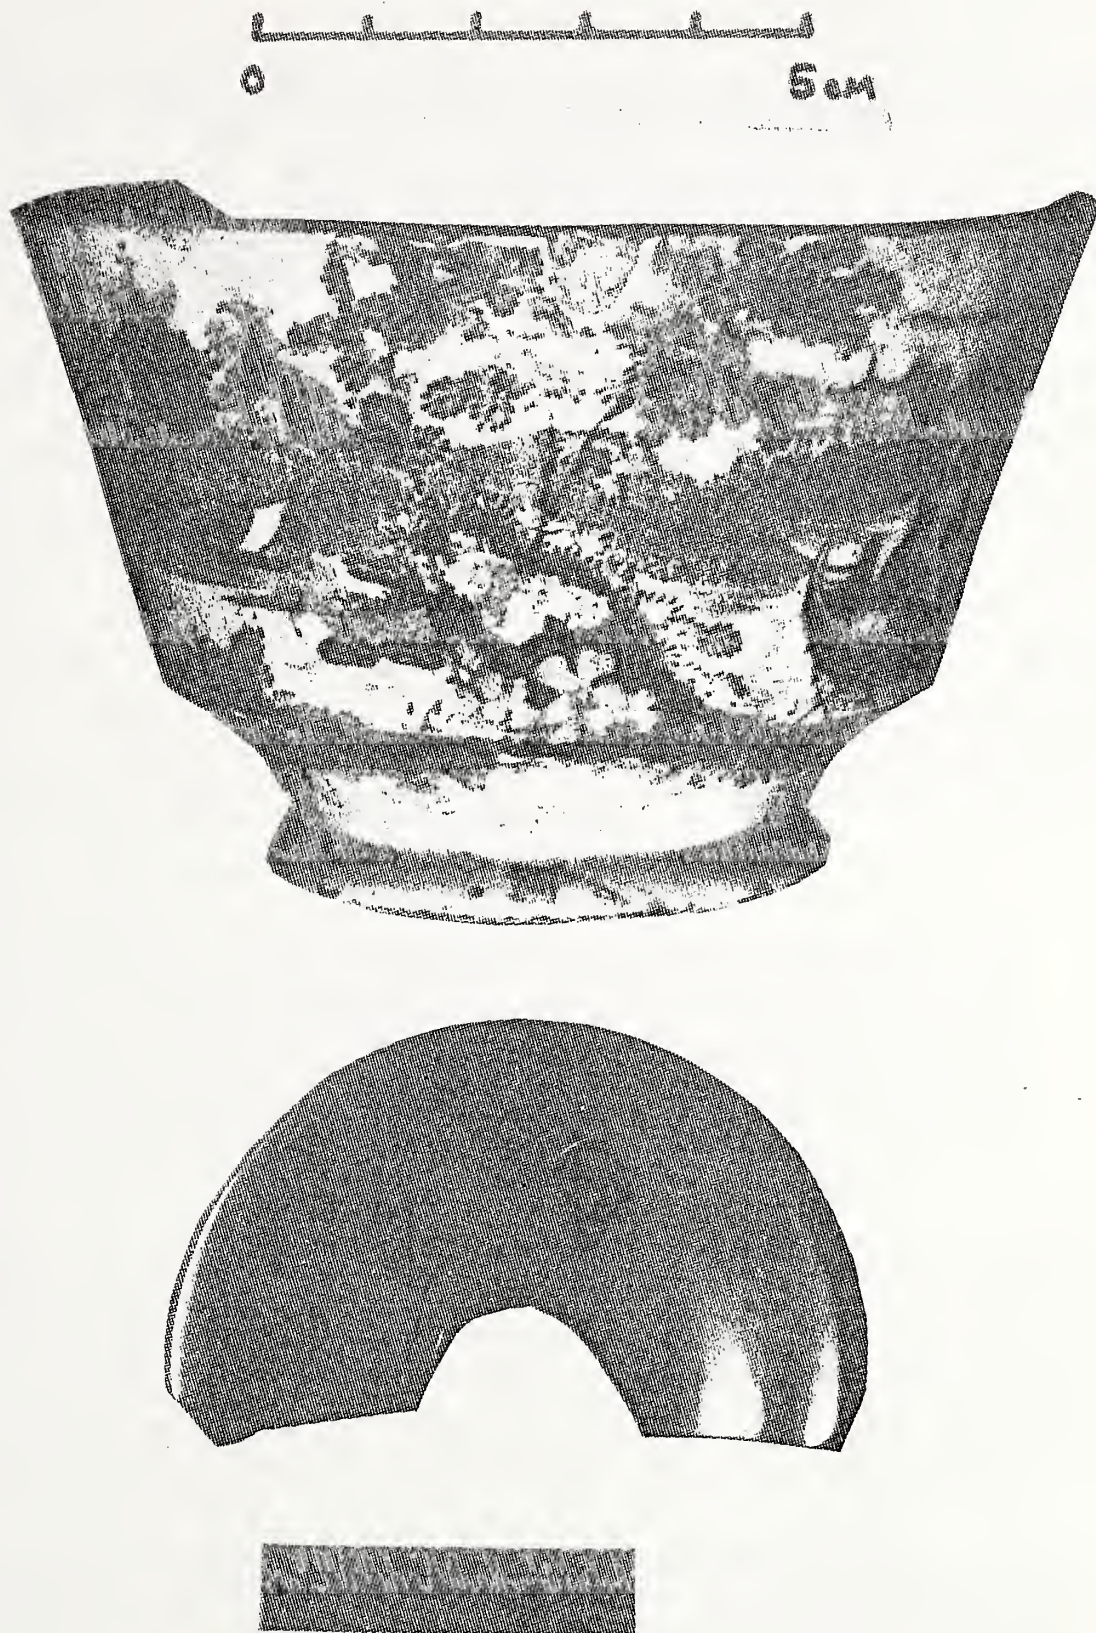
Figure 80. Porcelain Candle Holder and Earthenware Cup Recovered From Hagen's 1951 Excavations.

Located along the outside edge of the north wall of the barn, was found a small pit feature. The pit (Feature #8) was somewhat rectangular in plan and extended to a depth of approximately 76cm below surface. Artifact density was very low, but at -3' in depth, a porcelain candleholder, relief decorated stoneware cup fragment, and an undecorated whiteware sherd were found (Figure 80), suggesting a mid-19th century date (circa 1850-70).

Located at 35'6" L18, deep in the ashes present in this area, was a blue transfer print tea cup (Figure 80). This cup was found in what would have been the woodshed and is typical of wares circa 1830-50 associated with Lincoln's early years at the site. Beneath a back pier assumed to have been associated with either the woodhouse or the barn, was a glass sherd possibly from a lamp or lantern globe. Of unknown age, it is of blow-over-mold manufacture and had the letters, "E B REQUAS..." embossed on the edge.

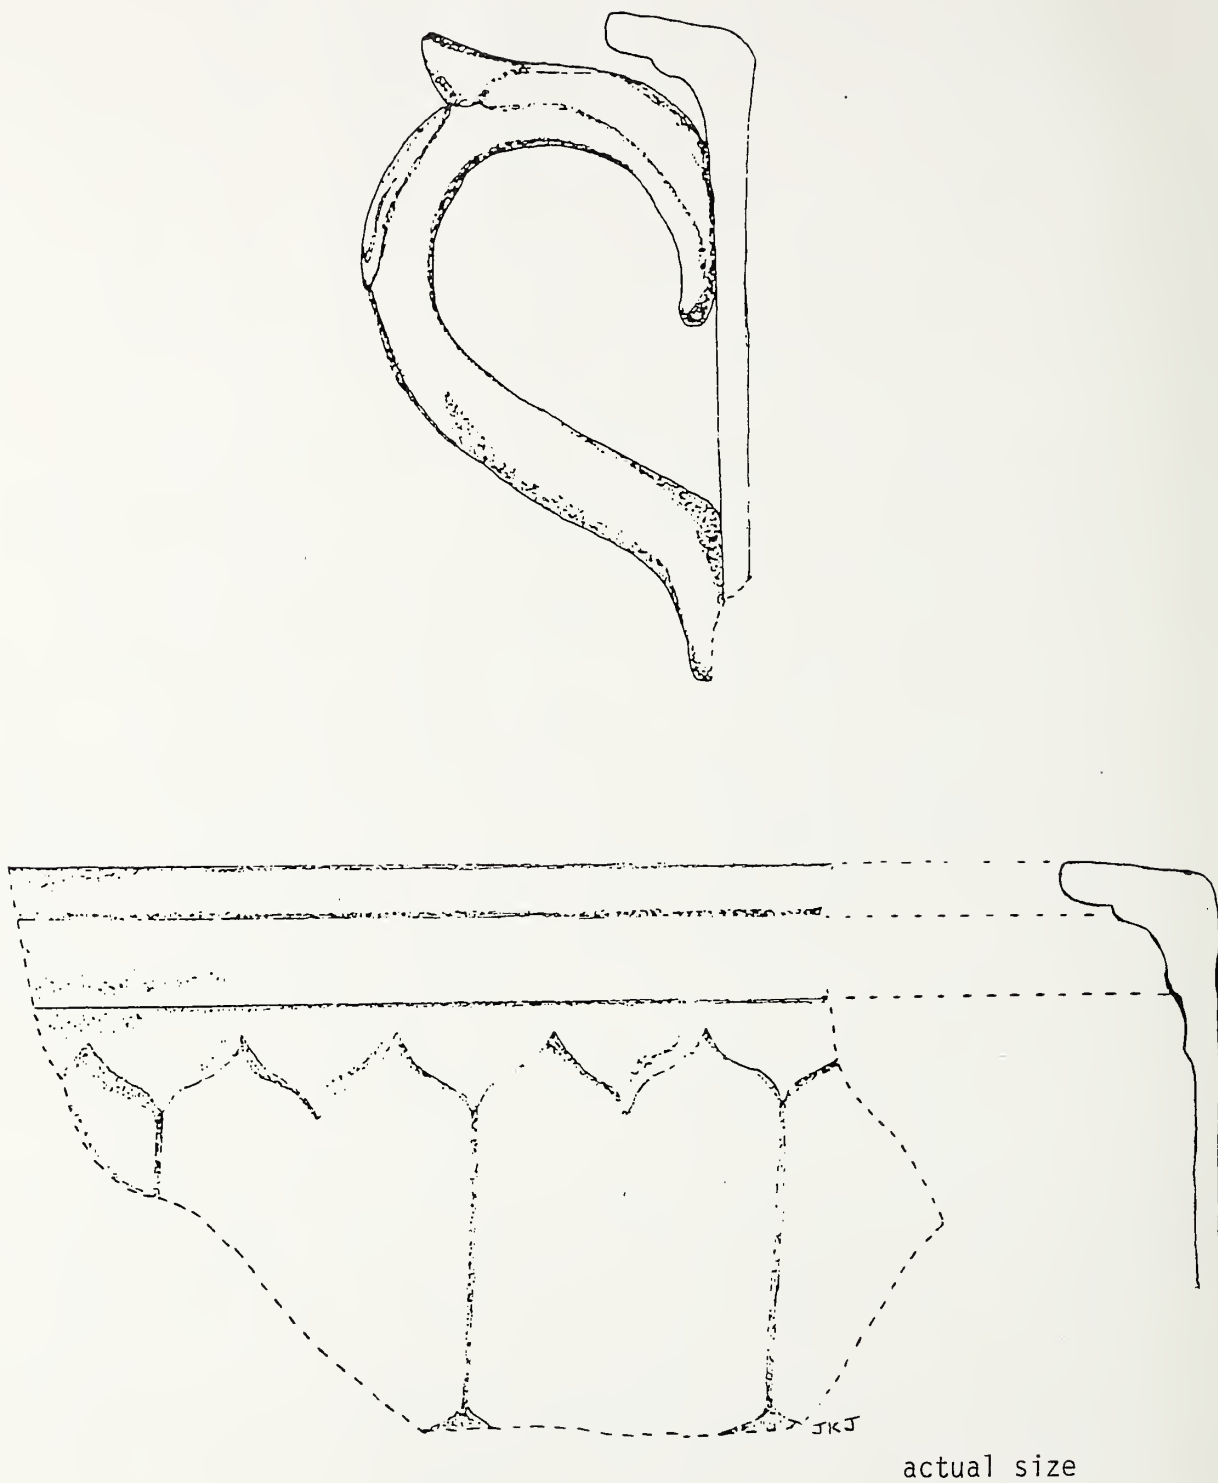
FIGURE 82. Lincoln Site, Relief Decorated Chamber Pot Found in Privy #3 During Hagen's 1951 Excavations.

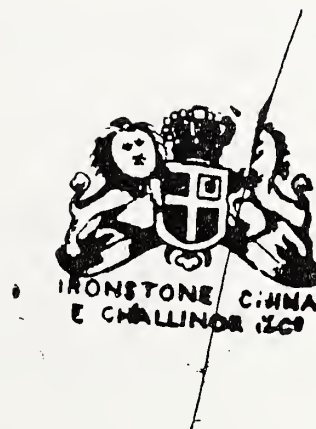
FIGURE 83. Ceramic Hallmarks From Vessels Recovered From the Rubbish Pit During Hagen's 1951 Excavations.

Several identifiable ceramic hallmarks (Figure 83) were found in this feature. One small restorable undecorated ironstone platter was marked "IRONSTONE CHINA / E. CHALLINOR & CO." Edward Challinor produced earthenware in his Staffordshire pottery from 1853-60 (Godden 1964: 137). Portions of a whiteware saucer marked, "ROYAL PATENT.../IRONSTONE.../TOMKINSON BRO." were also found. Godden (1964: 619) does not list a Tomkinson Brothers. Tomkinson and Billington operated a pottery at Longton between 1868-70 (Godden 1964: 619). Whether this mark post-dates or pre-dates this time is not known. A final ceramic hallmark consisted of a whiteware plate impressed "FELSPAR / EDWARDS AND SON / DALE HALL." This mark, associated with James Edwards and Son, Burslem, England was used on earthenwares and ironstones between 1851-82 (Godden 1964: 230-31). Wetherbee (1980: 46) illustrates a similar mark with a "True Scallop" pattern of relief decorated wares.

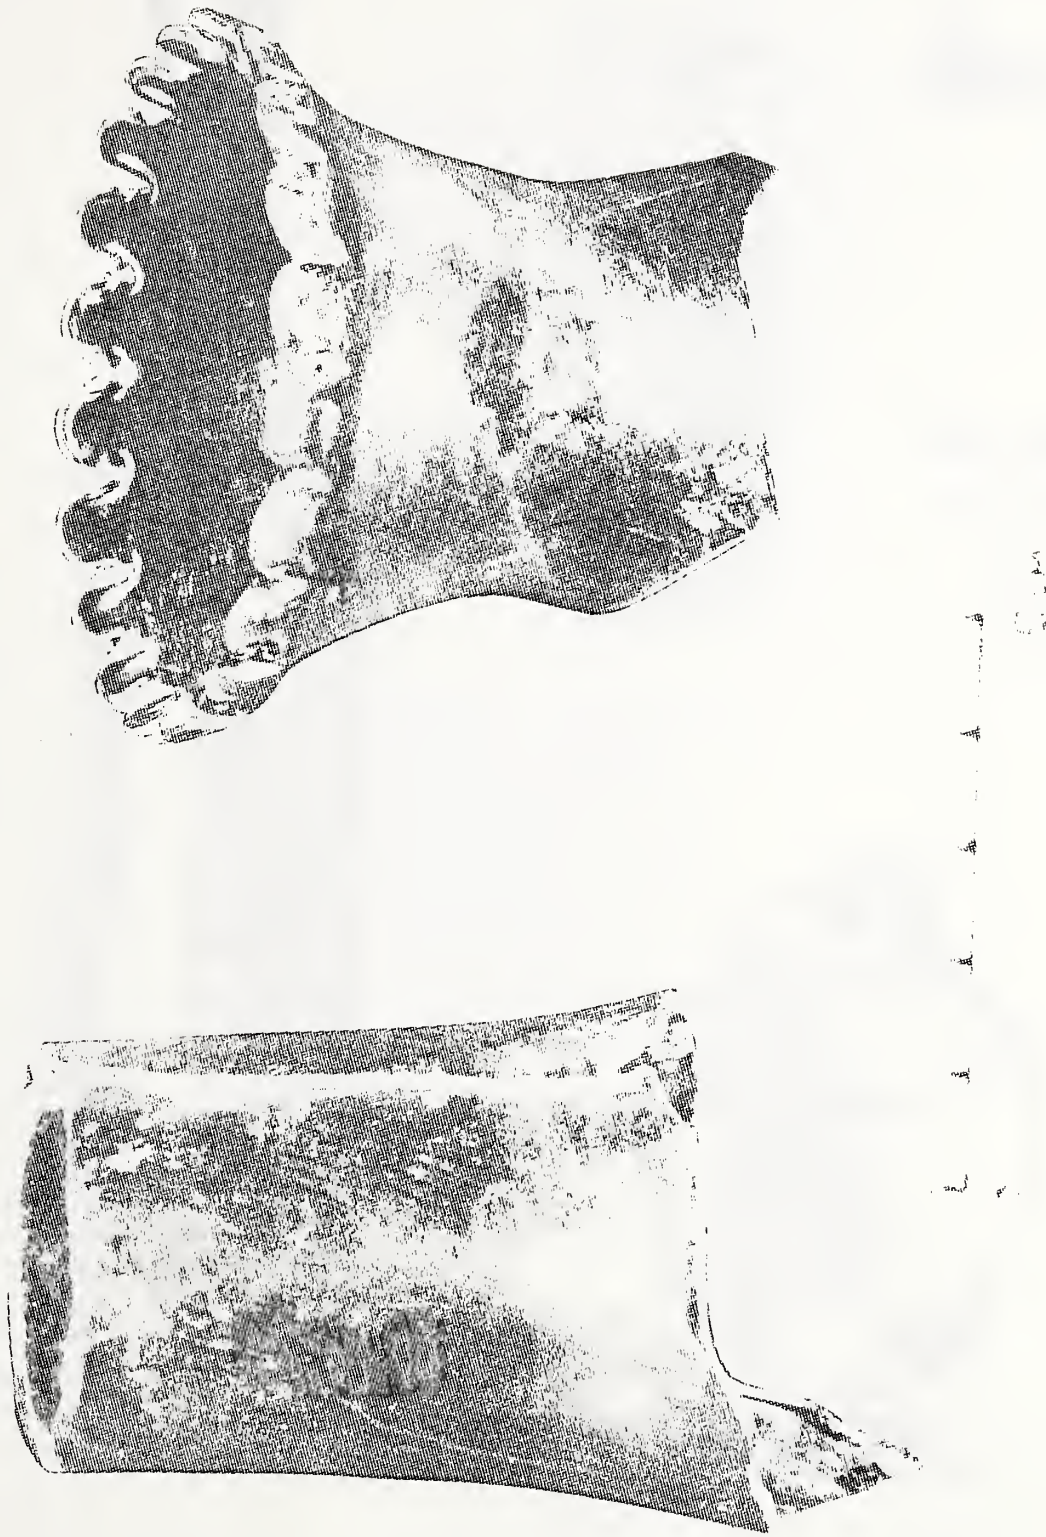
FIGURE 84. "Blow-Over-Mold" and "Crimped" Varieties of Chimney Globes Similar to Examples Found In the Rubbish Pit During Hagen's 1951 Excavations at the Lincoln Site. These two Examples Were Recovered From The Hughlett Site (Mansberger n.d.).

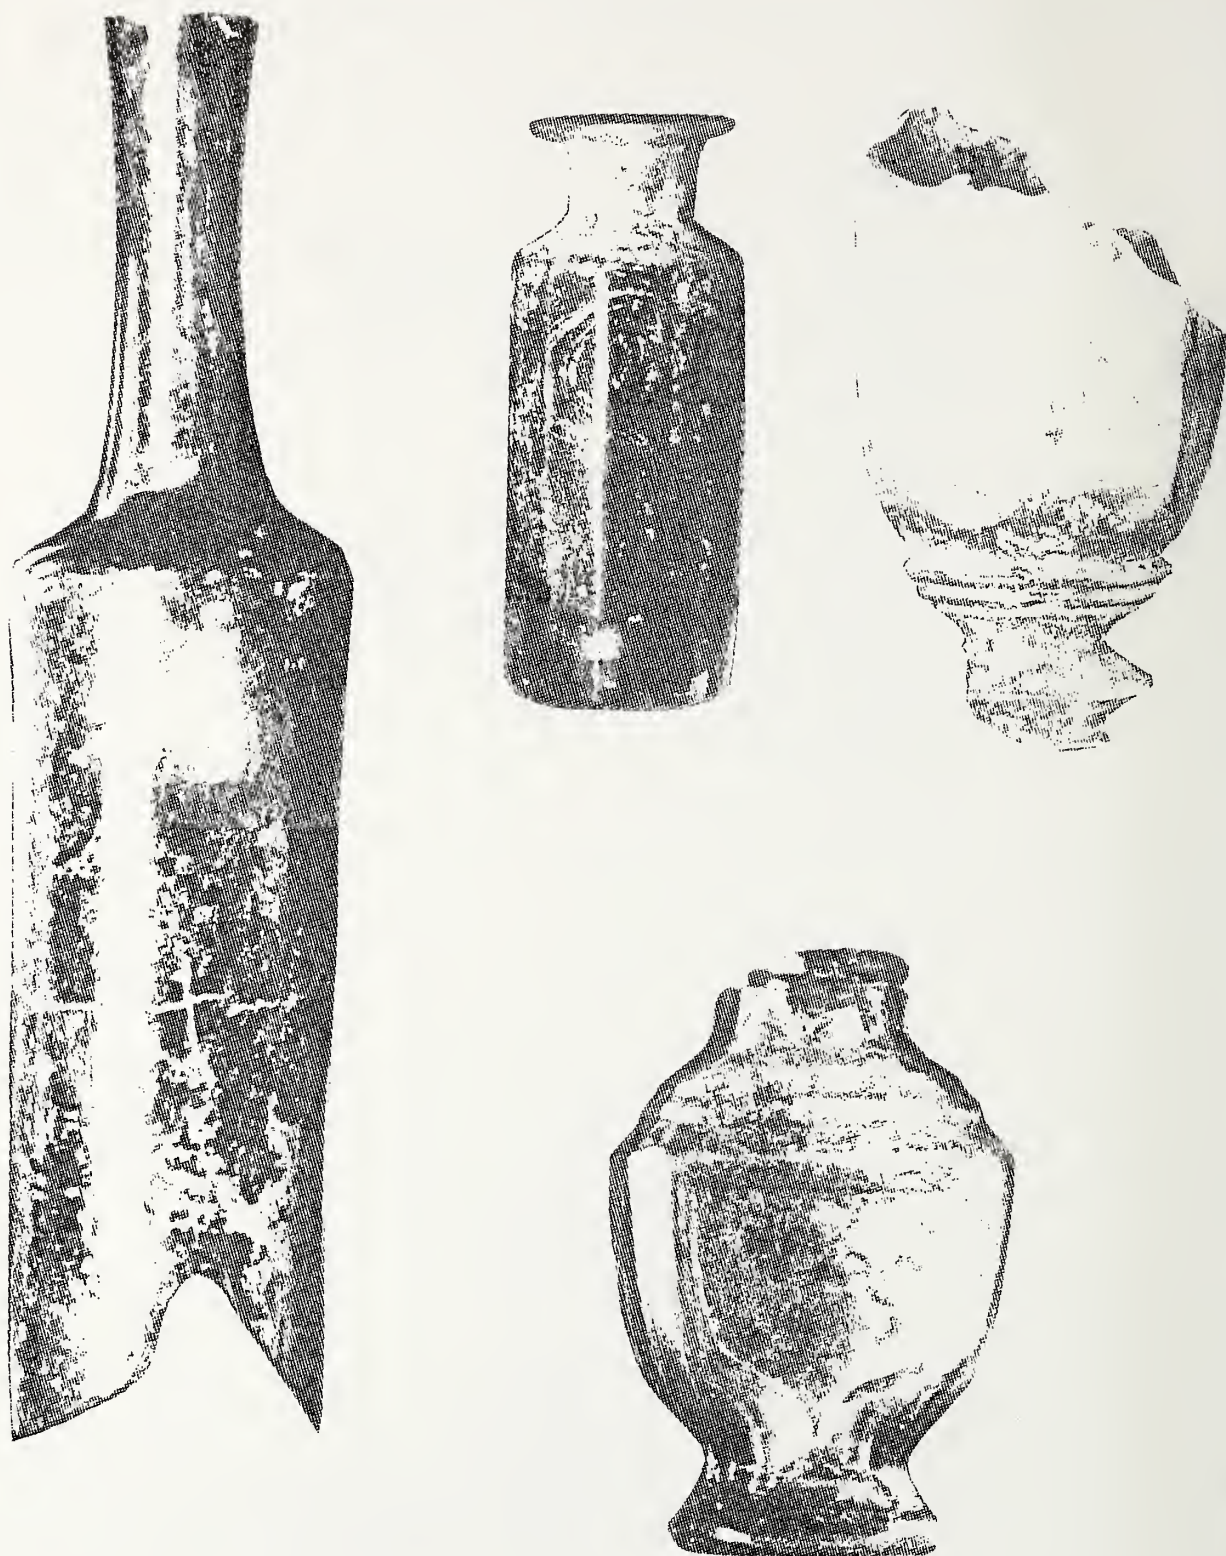
FIGURE 85. Miscellaneous Glass Items Recovered From Hagen's 1951 Excavations.

The largest single glass category was Tablewares (39.7%). The minimum number of tableware vessels from this pit consisted of 3 fluted tumblers (Figure 86), 2 cordial glasses (Figure 85), and 7 stemmed goblets (Figures 87-88). Two of the stemmed ware vessels did not have a pontiled base; these molded vessels had a decorative leaf design on their cup (Figure 89) and date probably from the 1860's or 1870's. The remainder of the stemware vessels (7) all had a rough pontil or ground pontil base. Of these pontiled vessels, Jane Shadel Spillman, Curator of American Glass at the Corning Museum of Glass, states that the stems appear more like those from the 1830's and 1840's than of the 1850's (personal communication).

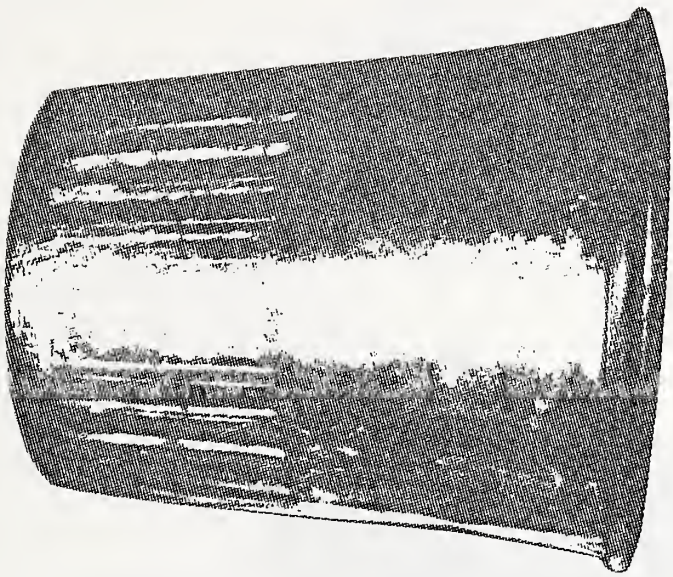
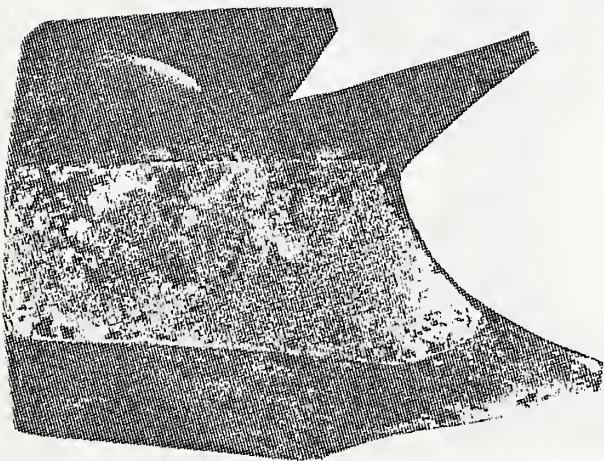
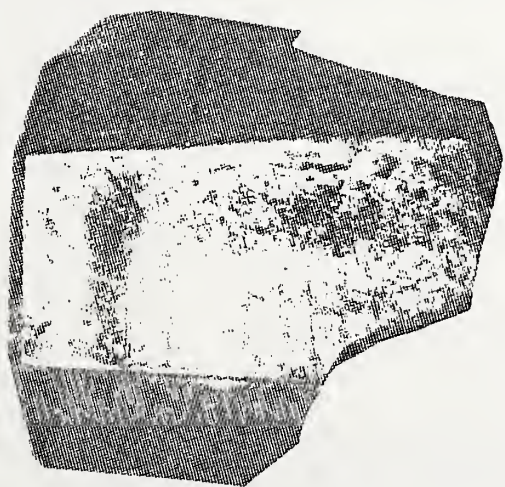
FIGURE 86. Glass Tumblers and Jelly Jar Recovered From the Hagen's 1951 Excavations.

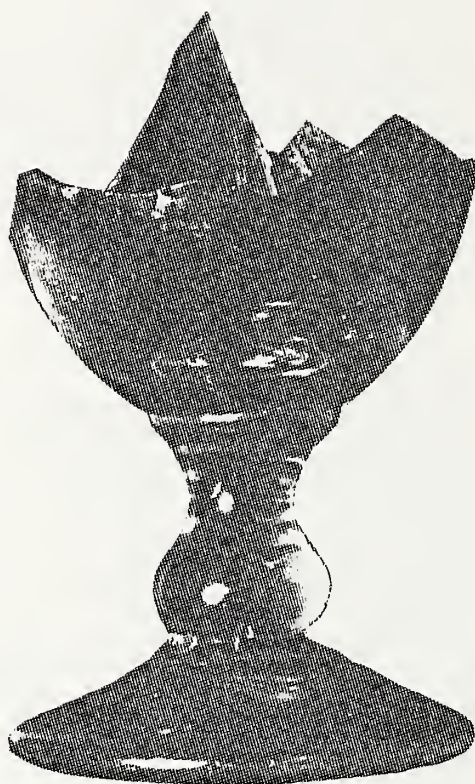
• FIGURE 87. Glass Stemware (Goblet) Recovered From Hagen's 1951 Excavations at the Lincoln Site.

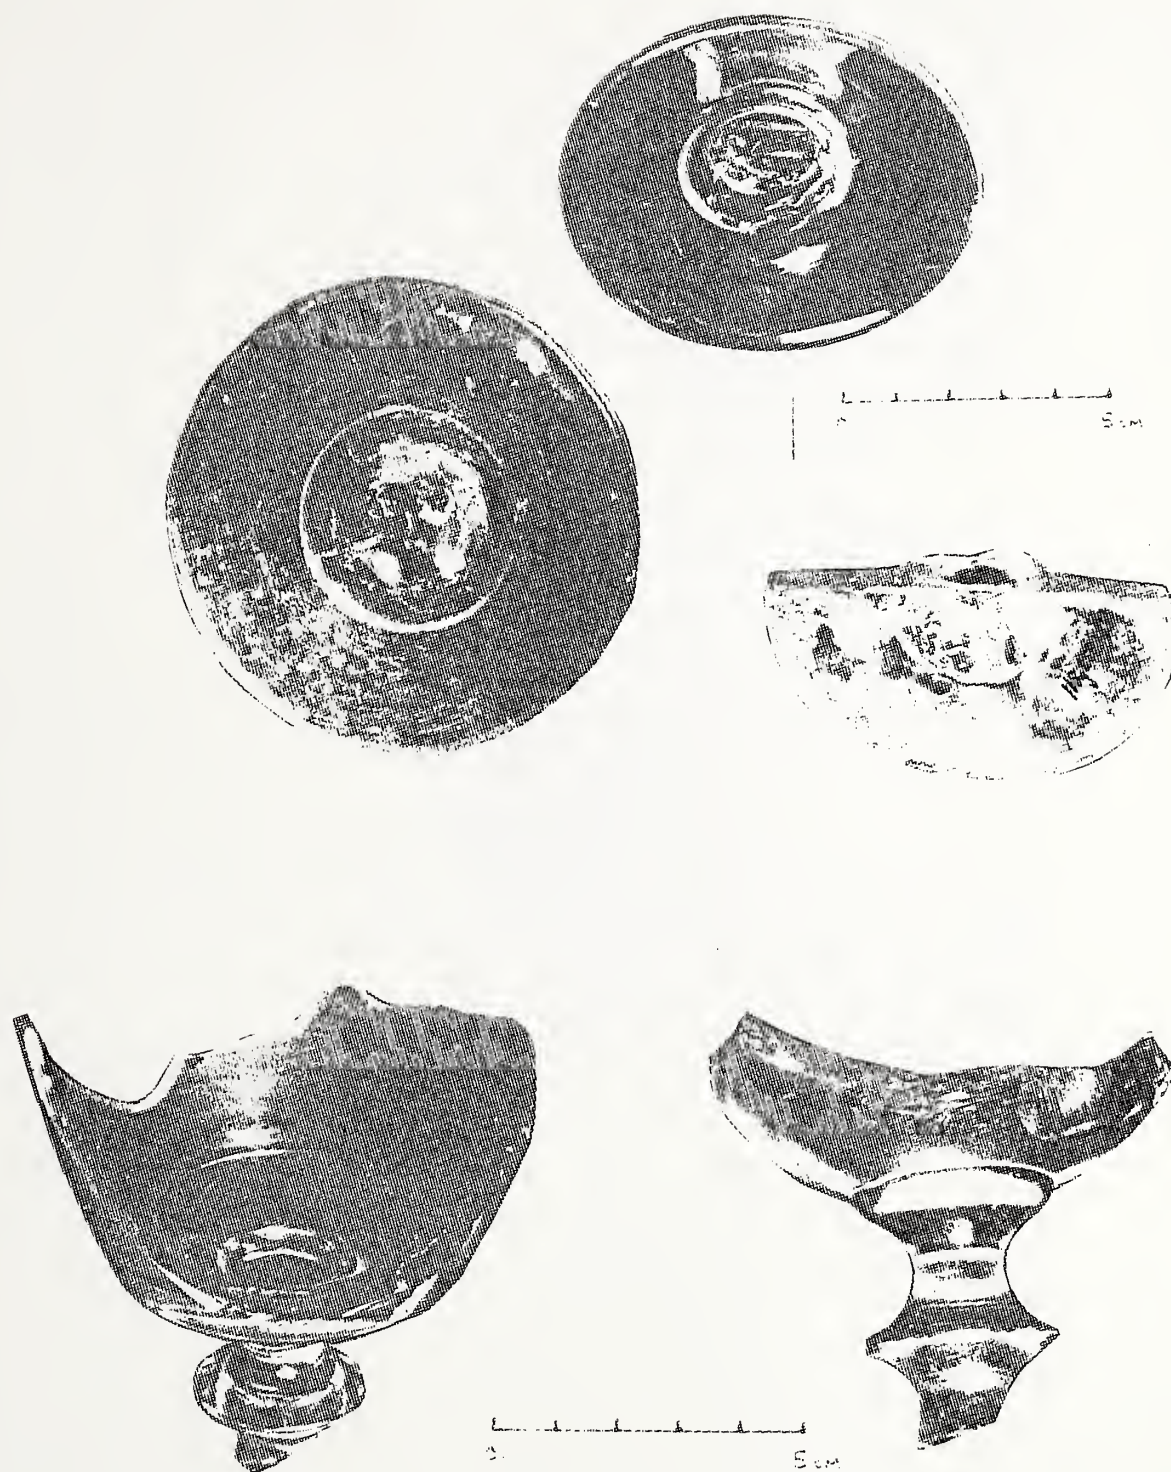
FIGURE 88. Glass Stemware Recovered From Hagen's 1951 Excavations at the Lincoln Site.

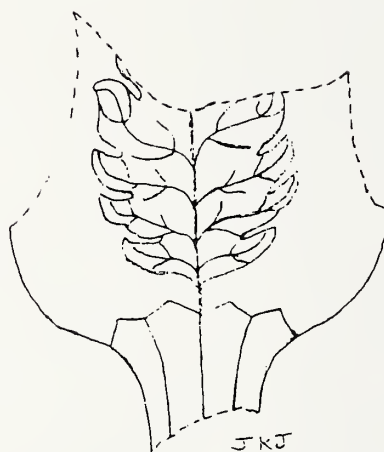
FIGURE 89. Molded Design On Glass Stemware Recovered From The Rubbish Pite During Hagen's 1951 Excavations.
